USCG Safety Alert on 'BilgMon 488' Bilge Alarm

URC19032 | 01 August 2019

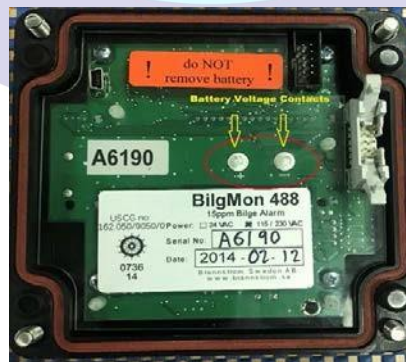
The specific monitor in these cases was the BilgMon 488 model manufactured by Brannstrom, a Swedish company. The older model, BilgMon 488 shown on the right, has a battery that is not replaceable by the crew inserted behind the circuit board of the Bilge Alarm. The purpose of the battery is to maintain the stored data and Real Time Clock (RTC) when the unit is disconnected from a power supply. The circuit board contains two contact points which provide the ability to measure the battery voltage. In all four cases, the battery voltage was extremely low and failed to provide the required 2.5 volts necessary to maintain the stored data without error.

As a result, when the data was viewed on the LCD screen it was scrambled and inaccurate. The operator's manual for this model clearly states that, under no circumstances should the battery be removed. Furthermore, a red warning sticker is affixed to the circuit board as pictured above. Attempting to remove the battery in this circumstance may cause an unrecoverable error, failure and data loss. A manufacturer's representative indicated that the battery was originally designed to last the lifetime of the device and that if the RTC stops due to a power supply failure combined with a low back-up battery voltage, the unit is locked down and the display reads "RTC check: FAILED." Click [here](#) for the applicable manual.

Ship owners / Managers / Operators whose vessels use the BilgMon 488 should remind vessel engineers to routinely review the stored data available through the LCD display ensuring that the data matches the information recorded in the ORB and actual OWS operations; and to maintain awareness that Port State Control Officers performing MARPOL examinations will verify that the BilgMon 488 is recording data properly and is aligned with the ORB entries. Avoid potential departure delays.

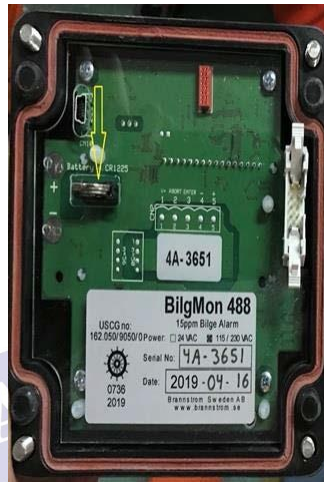
The newer model BilgMon 488 is equipped with a replaceable battery shown on the right below the yellow arrow. As a result, when the battery weakens the unit display will read "Batterylow: 0.5V Replace battery." The battery can then be safely removed because it utilizes a capacitor that ensures enough energy to maintain the stored data for several hours. Click [here](#) for the applicable manual.

To identify what model you may have note that the older type of master unit has serial numbers starting with "A," "AE," "BFA," and "EDA." The newer type of master unit has serial numbers starting with "4A," "4AE," "4BFA," and "4EDA." Click [here](#) for information on how to locate these numbers.
