Alert on detainable deficiencies

Following a recent Port State Control (PSC) inspection, several deficiencies have been imposed that resulted in the detention of the vessel. URACOS wishes to draw attention to these detainable deficiencies to avoid re-occurrence.

URC22015 | 01 March 2022

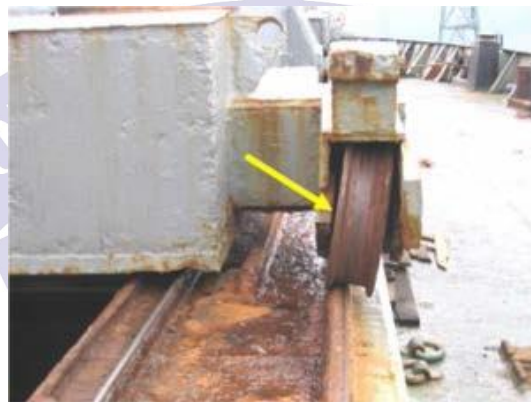
Another deficiency imposed was that *the hatch cover gasket of cargo hold no.03 has been found to be out of its rail and not properly maintained.*

Hatch cover maintenance routines should be drawn up following the manufacturer's recommendations and the ship's crew should be familiar with these requirements. Before the ship leaves any port, all the weather deck hatch covers should be properly closed, and all locking devices secured. Regular checks should be carried out on the

Once opened, hatch covers should be secured properly, using the chain stoppers, chocks or other devices recommended by the manufacturers. Hatch openings should be well-illuminated and if there are guard rails and stanchions fitted, these need to be fixed into place. Special care and attention should be paid to opening and closing of the hatch covers when the ship has an excessive trim or list. This is due to the possibility of the covers "running away" when in motion.

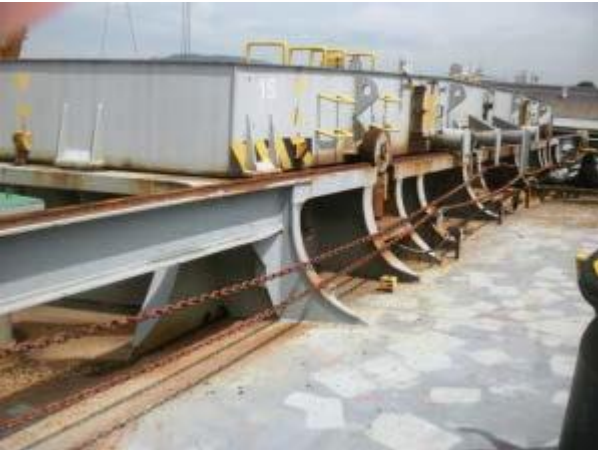
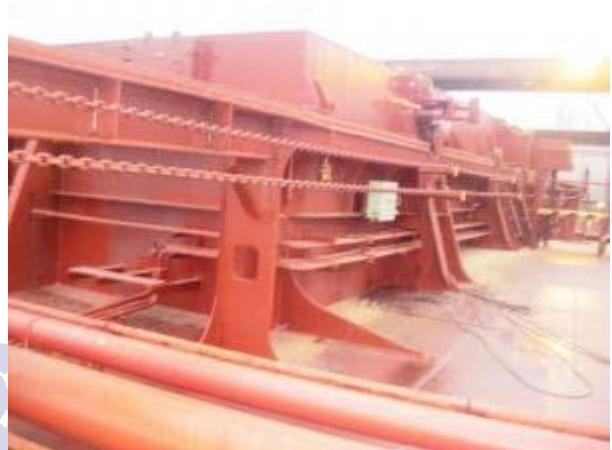
Two different vessels and their differences
