USCG Safety Alert on 'BilgMon 488' Bilge Alarm

URC19032 | 01 August 2019

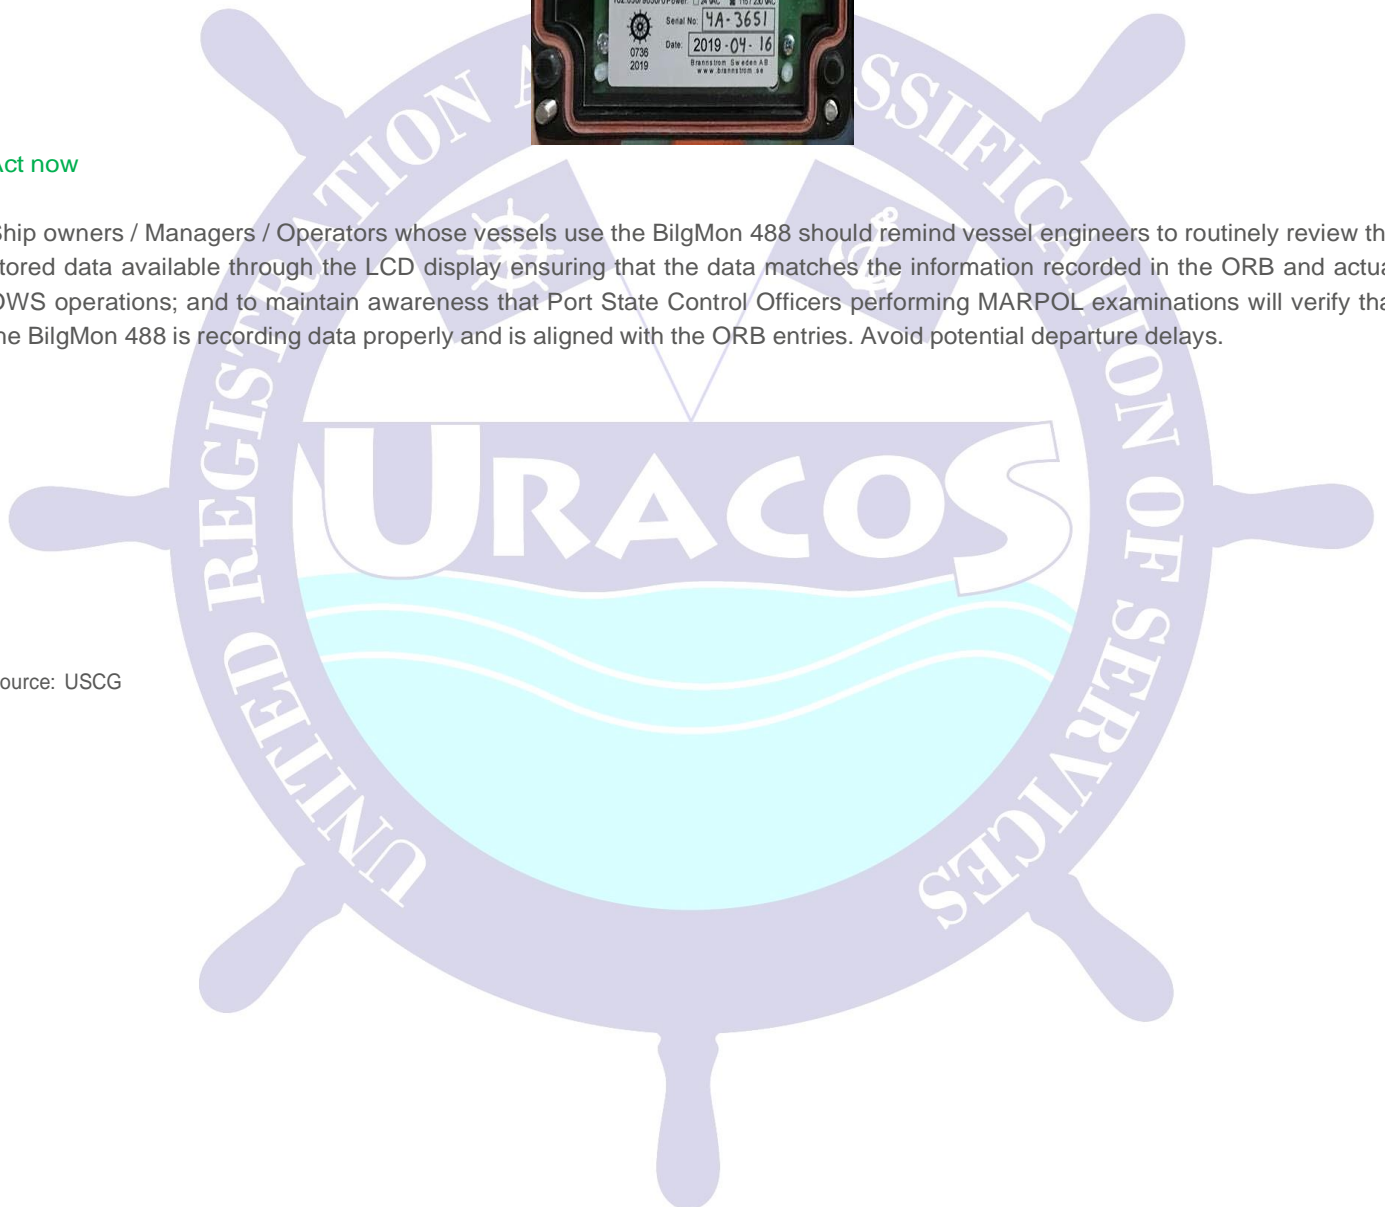
The specific monitor in these cases was the BilgMon 488 model manufactured by Brannstrom, a Swedish company. The older model, BilgMon 488 shown on the right, has a battery that is not replaceable by the crew inserted behind the circuit board of the Bilge Alarm. The purpose of the battery is to maintain the stored data and Real Time Clock (RTC) when the unit is disconnected from a power supply. The circuit board contains two contact points which provide the ability to measure the battery voltage. In all four cases, the battery voltage was extremely low and failed to provide the required 2.5 volts necessary to maintain the stored data without error.

As a result, when the data was viewed on the LCD screen it was scrambled and inaccurate. The operator's manual for this model clearly states that, under no circumstances should the battery be removed. Furthermore, a red warning sticker is affixed to the circuit board as pictured above. Attempting to remove the battery in this circumstance may cause an unrecoverable error, failure and data loss. A manufacturer's representative indicated that the battery was originally designed to last the lifetime of the device and that if the RTC stops due to a power supply failure combined with a low back-up battery voltage, the unit is locked down and the display reads "RTC check: FAILED." Click [here](#) for the applicable manual.

Ship owners / Managers / Operators whose vessels use the BilgMon 488 should remind vessel engineers to routinely review the stored data available through the LCD display ensuring that the data matches the information recorded in the ORB and actual OWS operations; and to maintain awareness that Port State Control Officers performing MARPOL examinations will verify that the BilgMon 488 is recording data properly and is aligned with the ORB entries. Avoid potential departure delays.
